**Flood Control Project Maintenance
Levee Inspections**

Maintenance Issue Types Only, Levee Inspection Report By Mile - Fall 2018

Reclamation District No. 2089 Stark

Waterway	Bank	Unit Miles	Inspection Start/End	Inspector
Unit No. 01 Old River	Right	1.51	10/31/2018 10/31/2018	Richard Willoughby

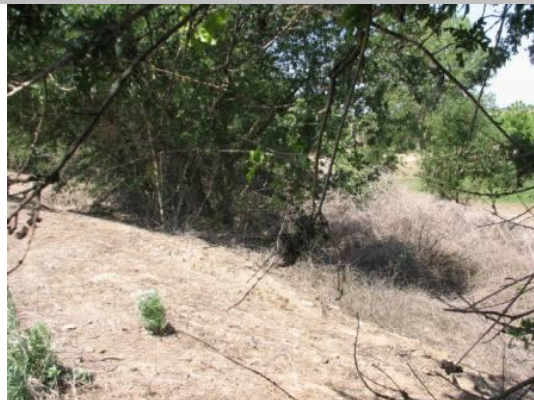
Photo 1 of 2 : FA_2018_RD2089_316_28_20180906_00025.jpg

LM Start	0.41	Rating **	U	Issue No.	28
LM End	0.46	Issue Type +	Ma	Location *	LS
Category	Earthen Levee			GPS Latitude/Longitude	
				Start	End
Item	Vegetation			37.809593°	37.809507°
				-121.391963°	-121.392907°
DWR ID	DWR_RD2089_01_s_2012_28				
Comment Code					
V2 : Remove the wild growth other than native grasses from the levee slopes.					
Inspector Comment					
Vegetation is too thick to allow access and visibility. Some thick patches of shrubs remain and continue to block visibility and access.

05/24/2011 Photo shows thick dead vegetation and continuation of trees in area that are preventing access and visibility of landside slope and toe.

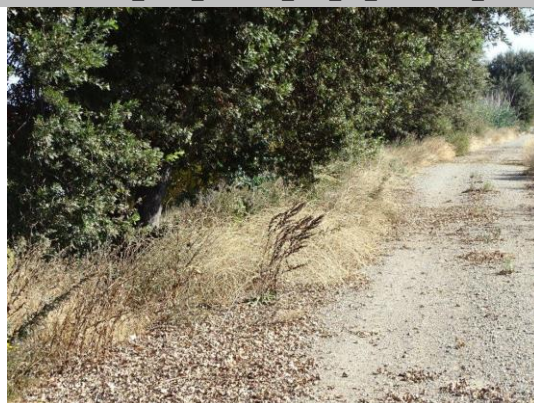
Photo 2 of 2 : FA_2018_RD2089_316_28_20181101_00058.jpg

Looking at dense veg on landward slope. (Fall 2018)

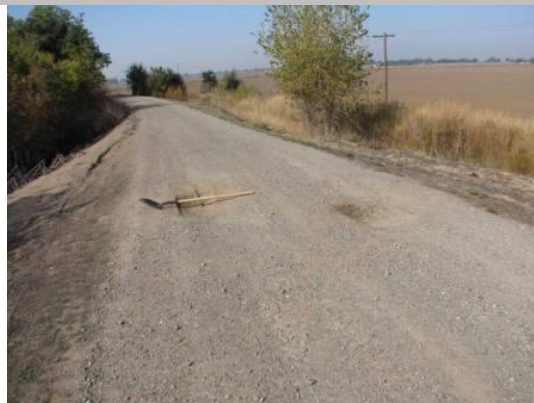
Photo 1 of 1 : FA_2018_RD2089_316_14_20180906_00013.jpg

LM Start	0.54	Rating **	M	Issue No.	14
LM End	0.54	Issue Type +	Ma	Location *	CR
Category	Earthen Levee			GPS Latitude/Longitude	
				Start	End
Item	Crown Surface / Depressions / Rutting			37.810087°	37.810087°
				-121.394200°	-121.394200°
DWR ID	DWR_RD2089_01_s_2012_14				
Comment Code					
C3 : Add appropriate gravel or road base. Grade and compact.					
Inspector Comment					
11/10/2011 Minor depressions will cause ponding.

11/10/2011 Depressions in crown.

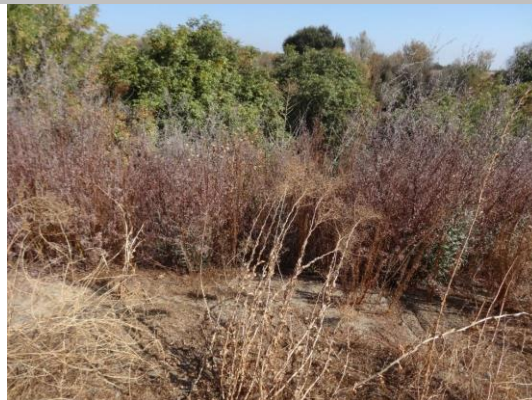
Photo 1 of 2 : FA_2018_RD2089_316_5_20180906_00007.jpg

09/28/2009: No major change observed; 5-foot vertical scarp is immediately downstream of where berm has tapered; site is recommended as local maintenance issue, per CLRO CES Evaluation 2008 Report; Site # is the same as RM29.6, LM0.60; previously rated "U".
 11/05/2008: No change observed; rodent holes on lower slope; wide levee crown. [2017 Site ID:RD2089U01RM29.61]

Front view of the site. The scarp erosion is at the levee slope but is not visible due to the dense vegetation at the site.

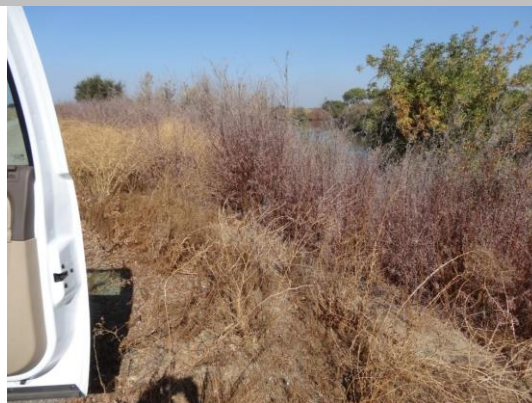
Photo 2 of 2 : FA_2018_RD2089_316_5_20180906_00008.jpg

Front view of the site. Note the very dense white willow thickets on site.

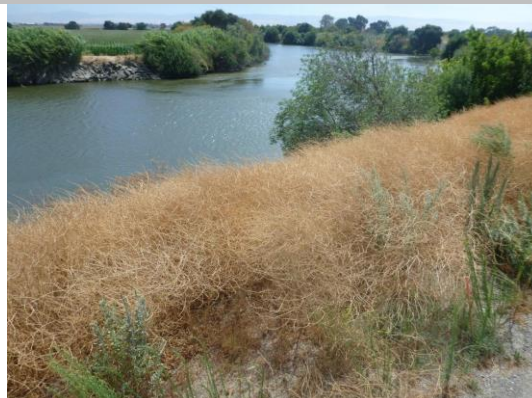
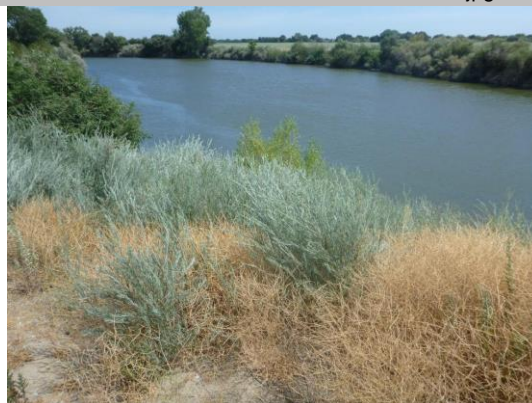
LM Start	0.67	Rating **	A/W	Issue No.	20
LM End	0.68	Issue Type +	Ma	Location *	
Category	Supplemental			GPS Latitude/Longitude	
				Start	End
Item	2017 Storm Damage			37.809700 °	37.809700 °
				-121.396300 °	-121.396400 °
DWR ID	DWR_RD2089_01_f _ 2017_20				
Comment Code					
Inspector Comment					
Levee Evaluation Comments					
Description:Slope protection repairs are needed along the waterside slope due to erosion and riprap displacement from high water. Based upon levee inspections, it was determined the waterside levee slope is eroding, deteriorating, and degrading. The eroded levee sections need to be restored back to design standards to prevent further deterioration and damage.					
Site ID No:512					
Site Designation:LMA-418					
Repair Type: Erosion					
Rating:Serious					
Field Date:8/14/2017					
Notes: deep erosion more than half way up slope.

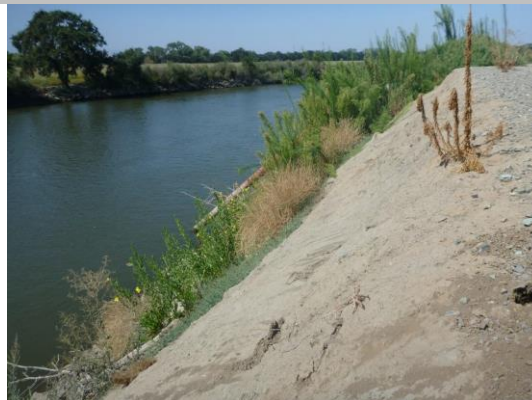
Description: Slope protection repairs are needed along the waterside slope due to erosion and riprap displacement from high water. Based upon levee inspections, it was determined the waterside levee slope is eroding, deteriorating, and degrading. The eroded levee sections need to be restored back to design standards to prevent further deterioration and damage.

LM Start	1.16	Rating **	A/W	Issue No.	30 (cont)
LM End	1.18	Issue Type +	Ma	Location *	WS
Category	Supplemental			GPS Latitude/Longitude	
				Start	End
Item	2017 Storm Damage			37.805600 °	37.805600 °
				-121.401700 °	-121.401900 °
DWR ID	DWR_RD2089_01_f _ 2017_30				
Comment Code					
Inspector Comment					
Levee Evaluation Comments					
Description:Slope protection repairs are needed along the waterside slope due to erosion and riprap displacement from high water. Based upon levee inspections, it was determined the waterside levee slope is eroding, deteriorating, and degrading. The eroded levee sections need to be restored back to design standards to prevent further deterioration and damage.					
Site ID No:511					
Site Designation:LMA-417					
Repair Type: Erosion					
Rating:Critical					
Field Date:8/16/2017					
Notes: Narrow levee with over steep slope

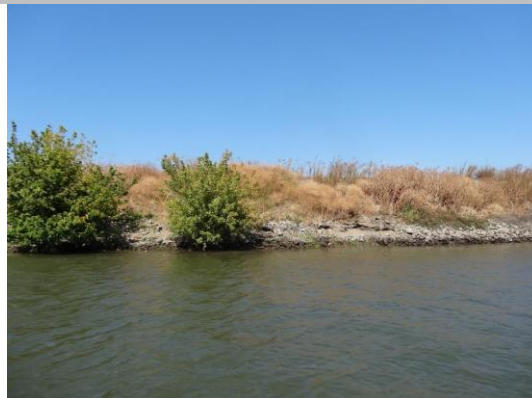
Photo 2 of 3 : FA_2018_RD2089_316_3_20180906_00005.jpg

Front view of the erosion.

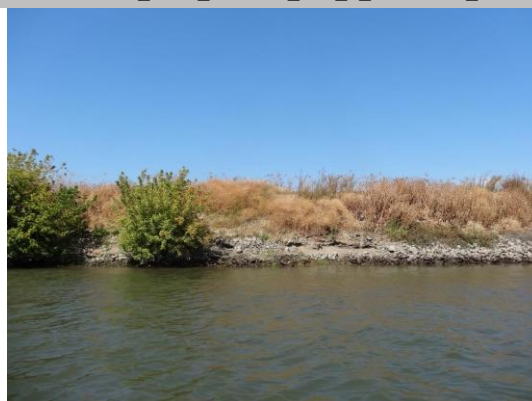
Photo 3 of 3 : FA_2018_RD2089_316_3_20180906_00006.jpg

Front view of the erosion.

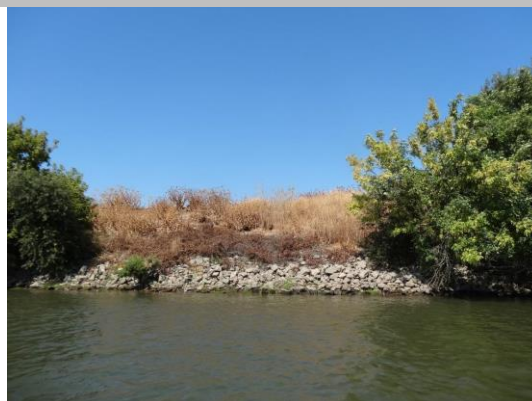
Photo 1 of 2 : FA_2018_RD2089_316_2_20180906_00002.jpg

LM Start	1.23	Rating **	M	Issue No.	2
LM End	1.24	Issue Type +	Ma	Location *	WS
Category	Supplemental			GPS Latitude/Longitude	
				Start	End
Item	DWR Erosion Survey			37.805580 °	37.805580 °
				-121.403010 °	-121.403010 °
DWR ID	RD2089U01RM29.04				
Comment Code					
Inspector Comment					
09/13/2017: No significant change observed. More vegetation observed at the site.					
09/16/2016: The river was not navigable near the site due to the dense water grass, so the site was visited by land survey. No significant change observed.					
06/25/2015: No significant change observed.					
07/02/2014: No significant change observed.					
08/13/2013: The erosion is around a tree at the levee toe. Dense vegetation is visible. [2017 Site ID:RD2089U01RM29.04]

Front view of the erosion.

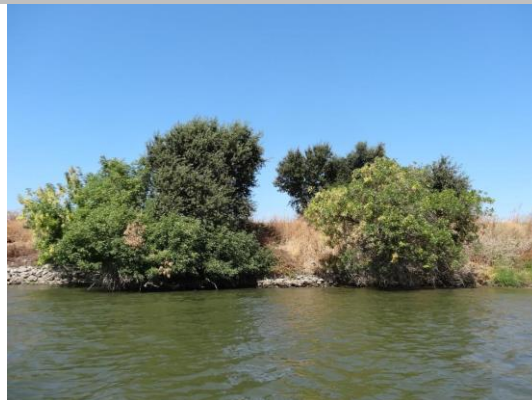
Photo 2 of 2 : FA_2018_RD2089_316_2_20180906_00003.jpg

Close view of the erosion.

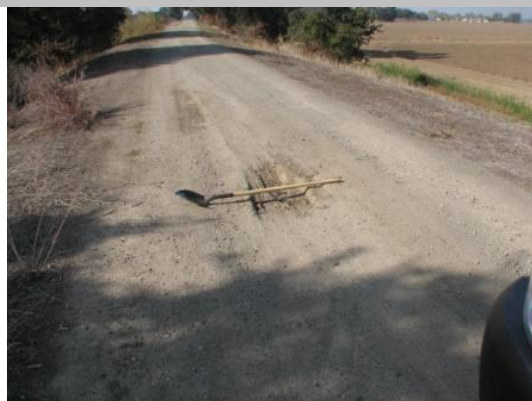
Photo 1 of 1 : FA_2018_RD2089_316_45_20180906_00034.jpg

11/10/2011 Roadway depression.

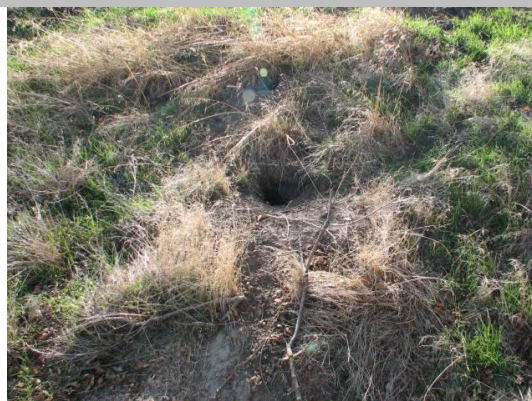
Photo 1 of 1 : FA_2018_RD2089_316_47_20180906_00035.jpg

11/10/2011 Active rodent burrow on landside slope.

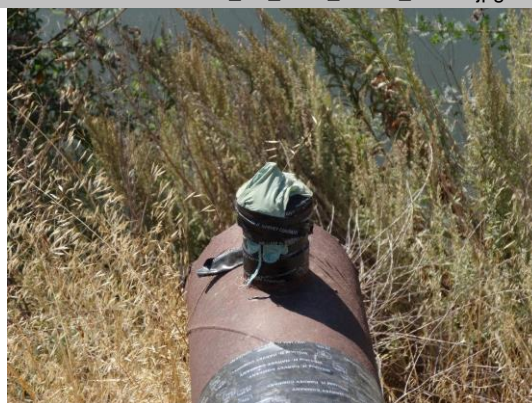
Photo 2 of 3 : UCIP_FA_2018_21585_36623.jpg

WS view: exposed steel pipe with siphon breaker. Looks siphon breaker needs repair.

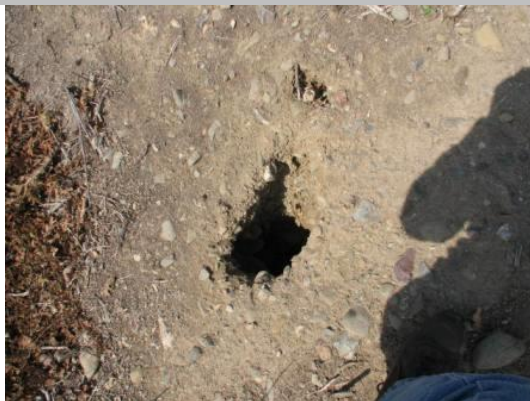
Photo 1 of 1 : FA_2018_RD2089_316_49_20180906_00036.jpg

11/10/2011 Deep burrow on waterside.

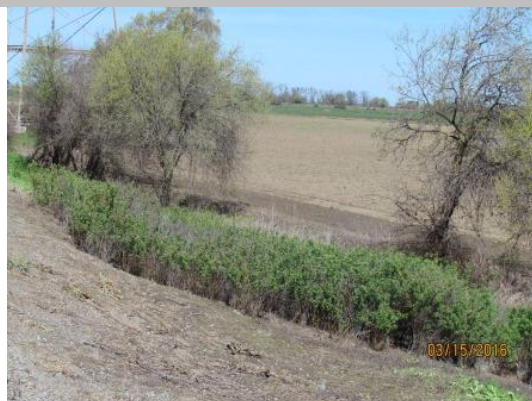
Photo 1 of 2 : FA_2018_RD2089_317_20_20180906_00021.jpg

View of the vegetation on the landside levee slope.

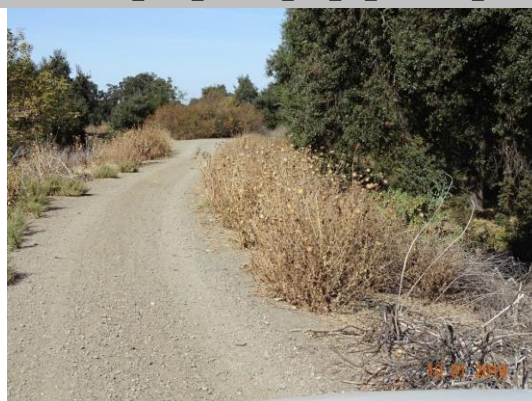
Photo 2 of 2 : FA_2018_RD2089_317_20_20181101_00064.jpg

View of dense veg on landward slope. (Fall 2018)

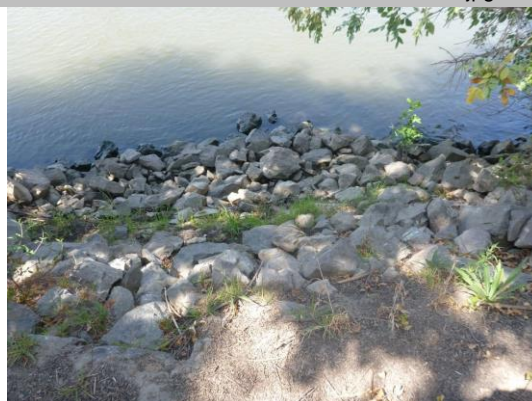
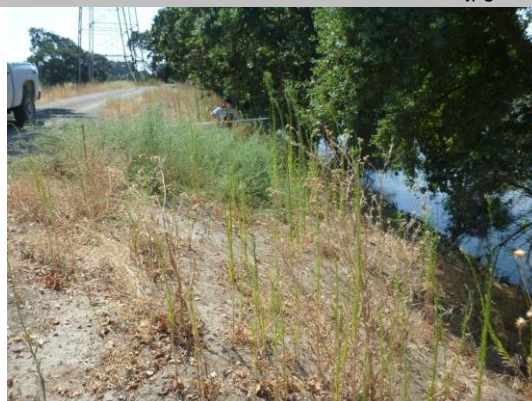
LM Start	0.20	Rating **	M	Issue No.	46
LM End	0.21	Issue Type +	Ma	Location *	
Category	Supplemental			GPS Latitude/Longitude	
				Start	End
Item	2017 Storm Damage			37.809100 °	37.809200 °
				-121.409800 °	-121.409900 °
DWR ID	DWR_RD2089_02_f_2017_46				
Comment Code					
Inspector Comment					
Levee Evaluation Comments					
Description:Slope protection repairs are needed along the waterside slope due to erosion and riprap displacement from high water. Based upon levee inspections, it was determined the waterside levee slope is eroding, deteriorating, and degrading. The eroded levee sections need to be restored back to design standards to prevent further deterioration and damage.					
Site ID No:509					
Site Designation:LMA-415					
Repair Type: Erosion					
Rating:Area of Concern					
Field Date:8/16/2017					
Notes: Displaced riprap at toe.

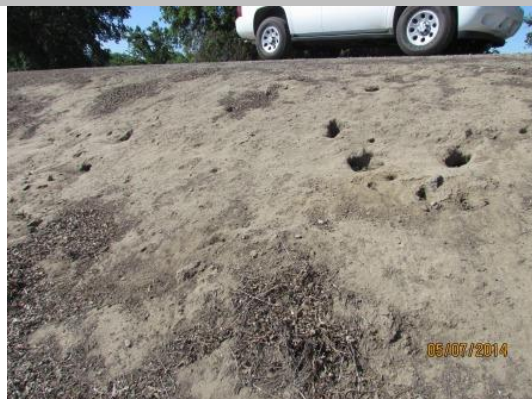
Photo 1 of 1 : FA_2018_RD2089_317_49_20180906_00045.jpg

LM Start	0.21	Rating **	M	Issue No.	49
LM End	0.21	Issue Type +	Ma	Location *	LS
Category	Earthen Levee			GPS Latitude/Longitude	
				Start	End
Item	Animal Control			37.809148°	37.809148°
				-121.409897°	-121.409897°
DWR ID	DWR_RD2089_02_s_2018_49				
Comment Code					
A3 : No rodents visible, but rodent burrows visible; need to backfill and compact or grout burrows.					
Inspector Comment

View of the multiple rodent burrows on the landside levee hinge and slope.

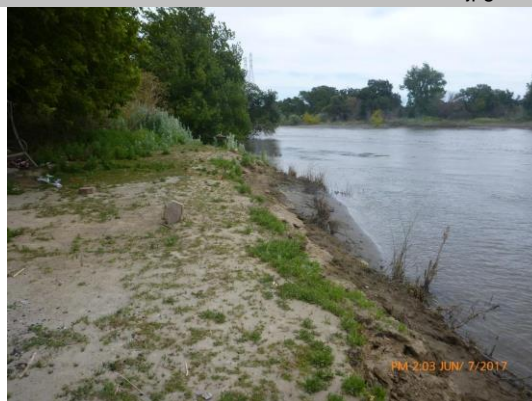
LM Start	0.32	Rating **	A/W	Issue No.	47
LM End	0.57	Issue Type +	Ma	Location *	
Category	Supplemental			GPS Latitude/Longitude	
				Start	End
Item	2017 Storm Damage			37.810020°	37.811810°
				-121.411550°	-121.415390°
DWR ID	DWR_RD2089_02_f_2017_47				
Comment Code					
Inspector Comment					
Levee Evaluation Comments					
Description:					
Site ID No:109					
Site Designation:335-103					
Repair Type: Erosion					
Rating:Area of Concern					
Field Date:6/7/2017					
Notes: vegetation too dense for evaluation

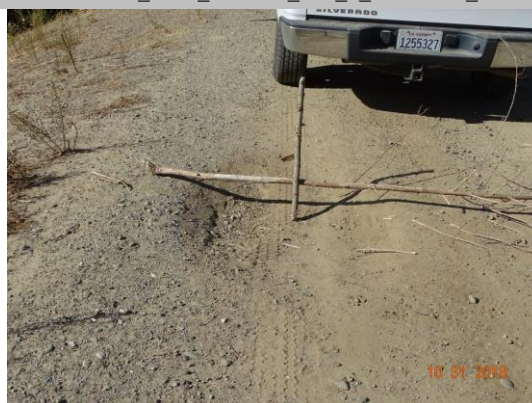
Photo 1 of 1 : FA_2018_RD2089_317_7_20181101_00065.jpg

LM Start	0.39	Rating **	U	Issue No.	7
LM End	0.39	Issue Type +	Ma	Location *	CR
Category	Earthen Levee			GPS Latitude/Longitude	
				Start	End
Item	Crown Surface / Depressions / Rutting			37.810140 °	37.810140 °
				-121.412906 °	-121.412906 °
DWR ID	DWR_RD2089_02_f_2018_7				
Comment Code					
C2 : Repair depressions or ruts in the crown or slope.					
Inspector Comment					
Large depression on levee crown.

View of depression greater than six inches on levee crown. (Fall 2018)

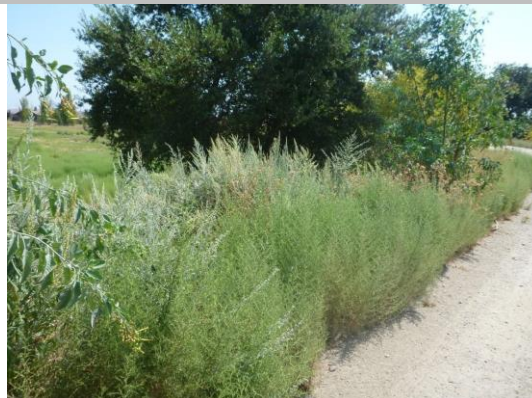
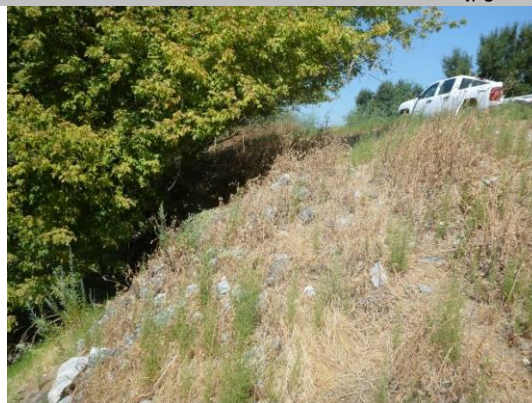
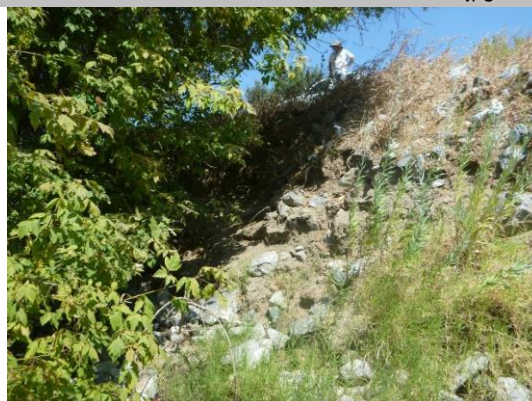
LM Start	0.39	Rating **	A/W	Issue No.	50
LM End	0.41	Issue Type +	Ma	Location *	
Category	Supplemental			GPS Latitude/Longitude	
				Start	End
Item	2017 Storm Damage			37.810150 °	37.810270 °
				-121.412930 °	-121.413240 °
DWR ID	DWR_RD2089_02_f _ 2017_50				
Comment Code					
Inspector Comment					
Levee Evaluation Comments					
Description:Slope protection repairs are needed along the waterside slope due to erosion and riprap displacement from high water. Based upon levee inspections, it was determined the waterside levee slope is eroding, deteriorating, and degrading. The eroded levee sections need to be restored back to design standards to prevent further deterioration and damage.					
Site ID No:508					
Site Designation:LMA-414					
Repair Type: Erosion					
Rating:Serious					
Field Date:8/16/2017					
Notes: Large erosion around tree with a 12' vertical cut.

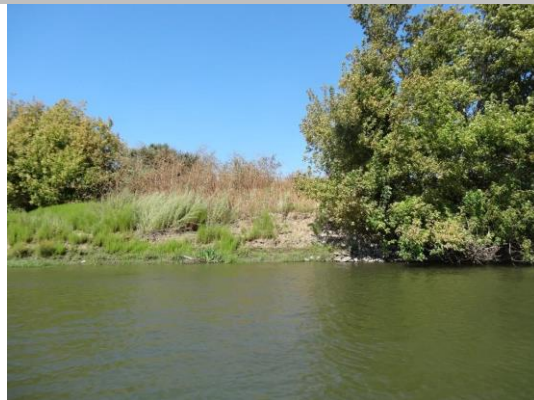
Photo 1 of 3 : FA_2018_RD2089_317_1_20180906_00001.jpg

Front view of the site.

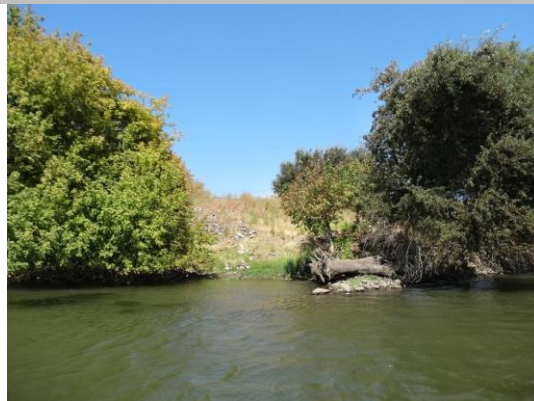
Photo 2 of 3 : FA_2018_RD2089_317_1_20180906_00002.jpg

Close view of the erosion.

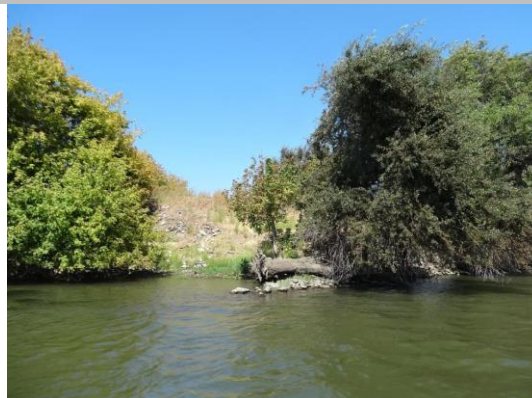
Photo 3 of 3 : FA_2018_RD2089_317_1_20180906_00003.jpg

Close view of the erosion.

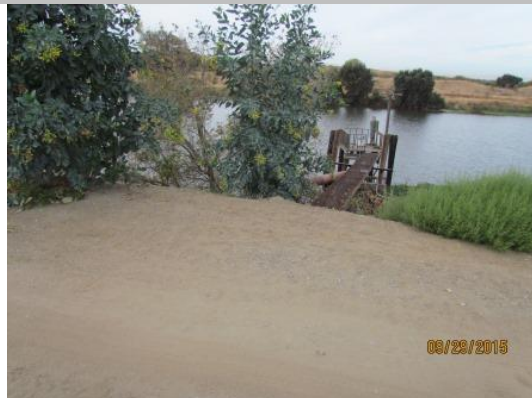
Photo 4 of 4 : FA_2018_RD2089_317_35_20180906_00031.jpg

View of the levee crown depression looking to the waterside.

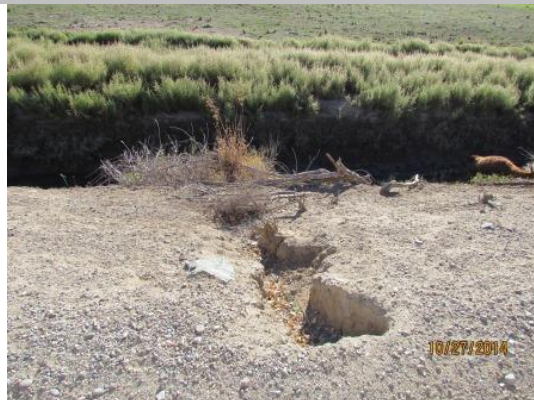
Photo 1 of 1 : FA_2018_RD2089_317_15_20180906_00016.jpg

LM Start	0.76	Rating **	M	Issue No.	15
LM End	0.76	Issue Type +	Ma	Location *	LS
Category	Earthen Levee			GPS Latitude/Longitude	
				Start	End
Item	Erosion / Bank Caving			37.813934 °	37.813934 °
				-121.414320 °	-121.414320 °
DWR ID	DWR_RD2089_02_f_2014_15				
Comment Code					
E2 : Schedule repair of erosion site prior to the next inspection.					
Inspector Comment

View of the scour from surface runoff on the landside levee slope.

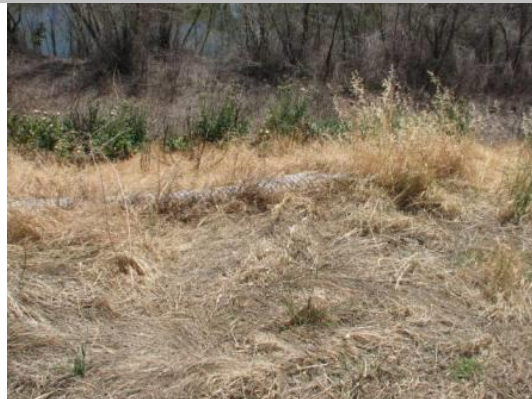
Photo 1 of 1 : FA_2018_RD2089_317_41_20180906_00036.jpg

05/24/2011 Old CMP left on waterside levee slope, needs to be removed.

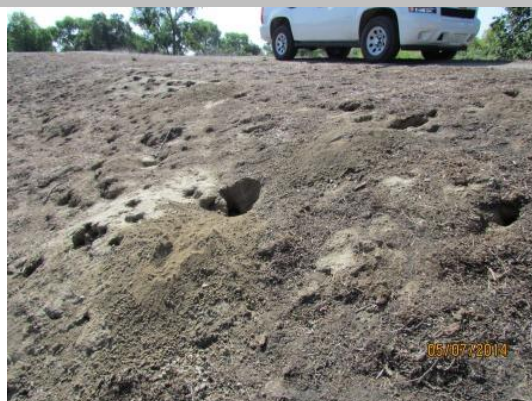
Photo 1 of 1 : FA_2018_RD2089_317_5_20180906_00005.jpg

View of the rodent holes on the landside levee slope.

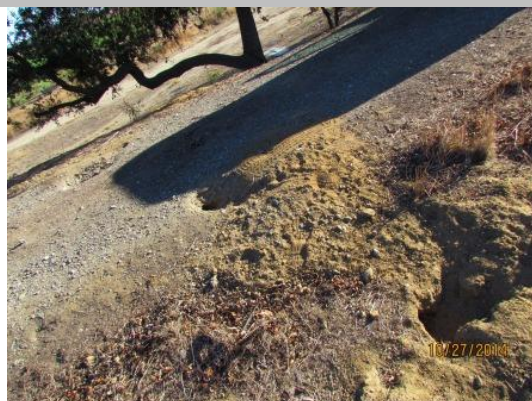
Photo 1 of 2 : FA_2018_RD2089_317_12_20180906_00012.jpg

View of several large rodent holes on the levee crown.

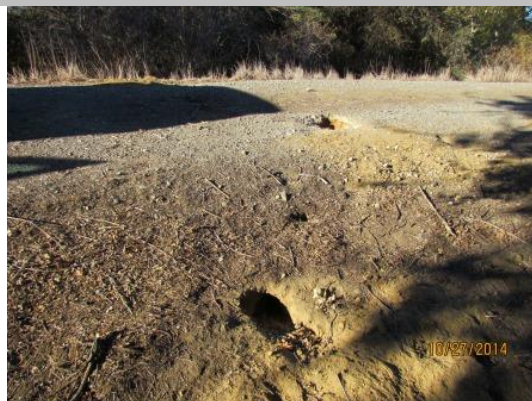
Photo 2 of 2 : FA_2018_RD2089_317_12_20180906_00013.jpg

View of several rodent burrows on landside levee hinge and crown.

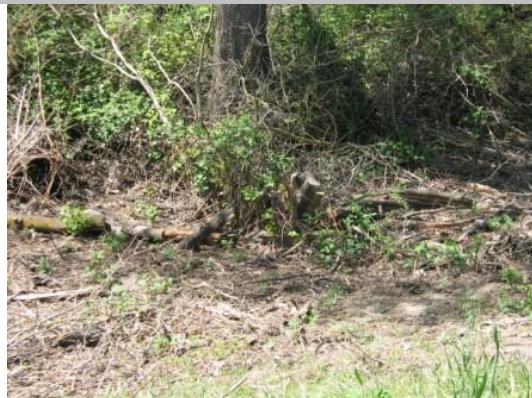
Photo 1 of 1 : FA_2018_RD2089_317_29_20180906_00027.jpg

Tree stump >2" left after vegetation and tree removal.

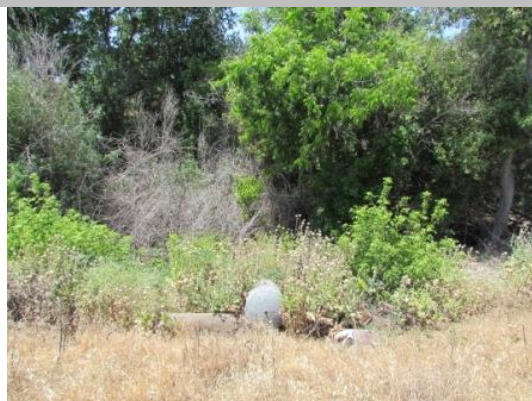
Photo 1 of 1 : FA_2018_RD2089_317_17_20180906_00018.jpg

View of water tanks disposed on waterside slope.

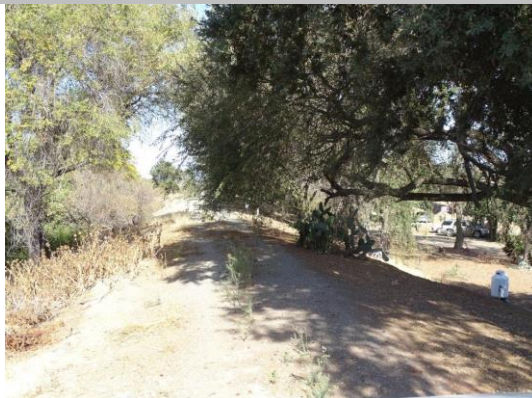
Photo 1 of 1 : FA_2018_RD2089_317_33_20181101_00068.jpg

Looking west at trees overhanging crown of levee. (Fall 2018)

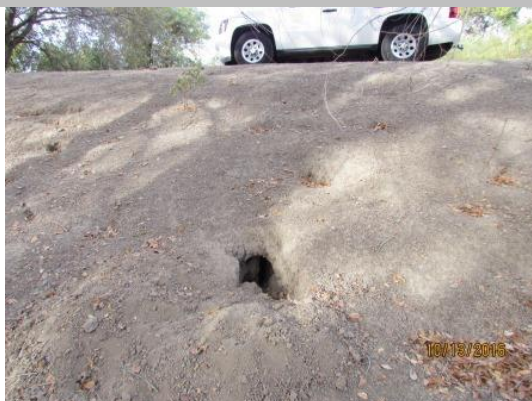
Photo 1 of 1 : FA_2018_RD2089_317_19_20180906_00020.jpg

View of the rodent burrow in the landside levee slope.
